1  
ESL-TR-85-23

## Optimum Aircraft Rescue Tool

FINAL REPORT

ENGINEERING & SERVICES LABORATORY  
AIR FORCE ENGINEERING & SERVICES CENTER  
TYNDALL AIR FORCE BASE, FLORIDA 32403

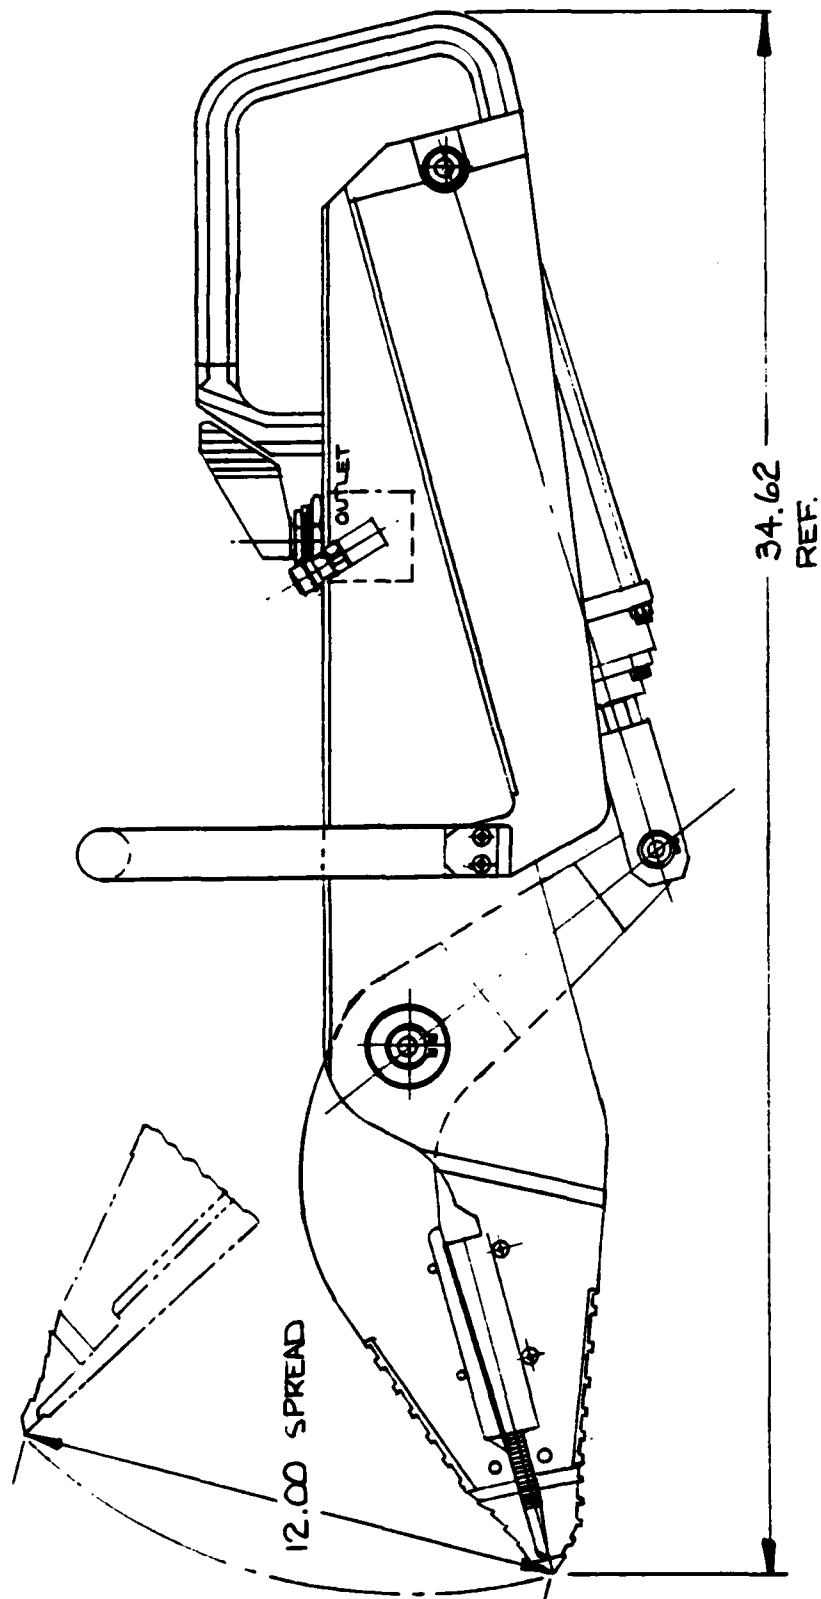
Figure E-1. Rescue Tool Configuration

The rescue tool shall be designed and constructed to permit easy operation, inspection, maintenance, and storage. The rescue tool handling and controls shall be designed so that they may be operated by personnel wearing heavy work or flight gloves or Arctic mittens. The rescue tool
